Blakemoorgate

The remains of two miners' cottages at Blakemoorgate at the northern end of the Stiperstones are being renovated by Natural England. Even before restoration is complete they already provide a clear indication of the way of life of Snailbeach Miners.

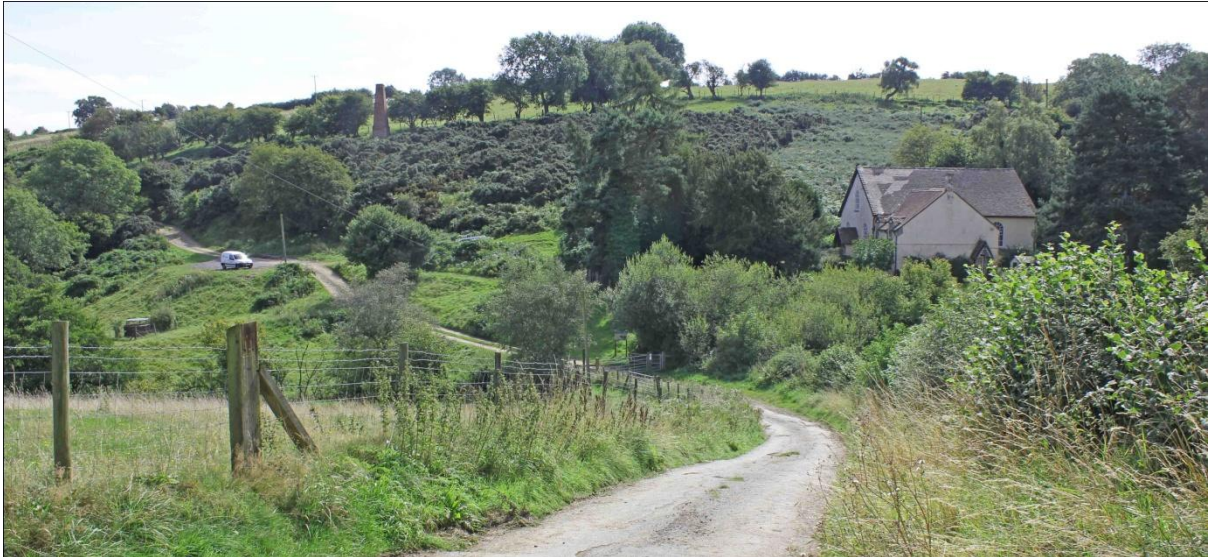
From there, follow the narrow road which is signposted to Lordshill. As the road emerges from woodland into fields the circular stone built caps on old mine shafts can be seen.

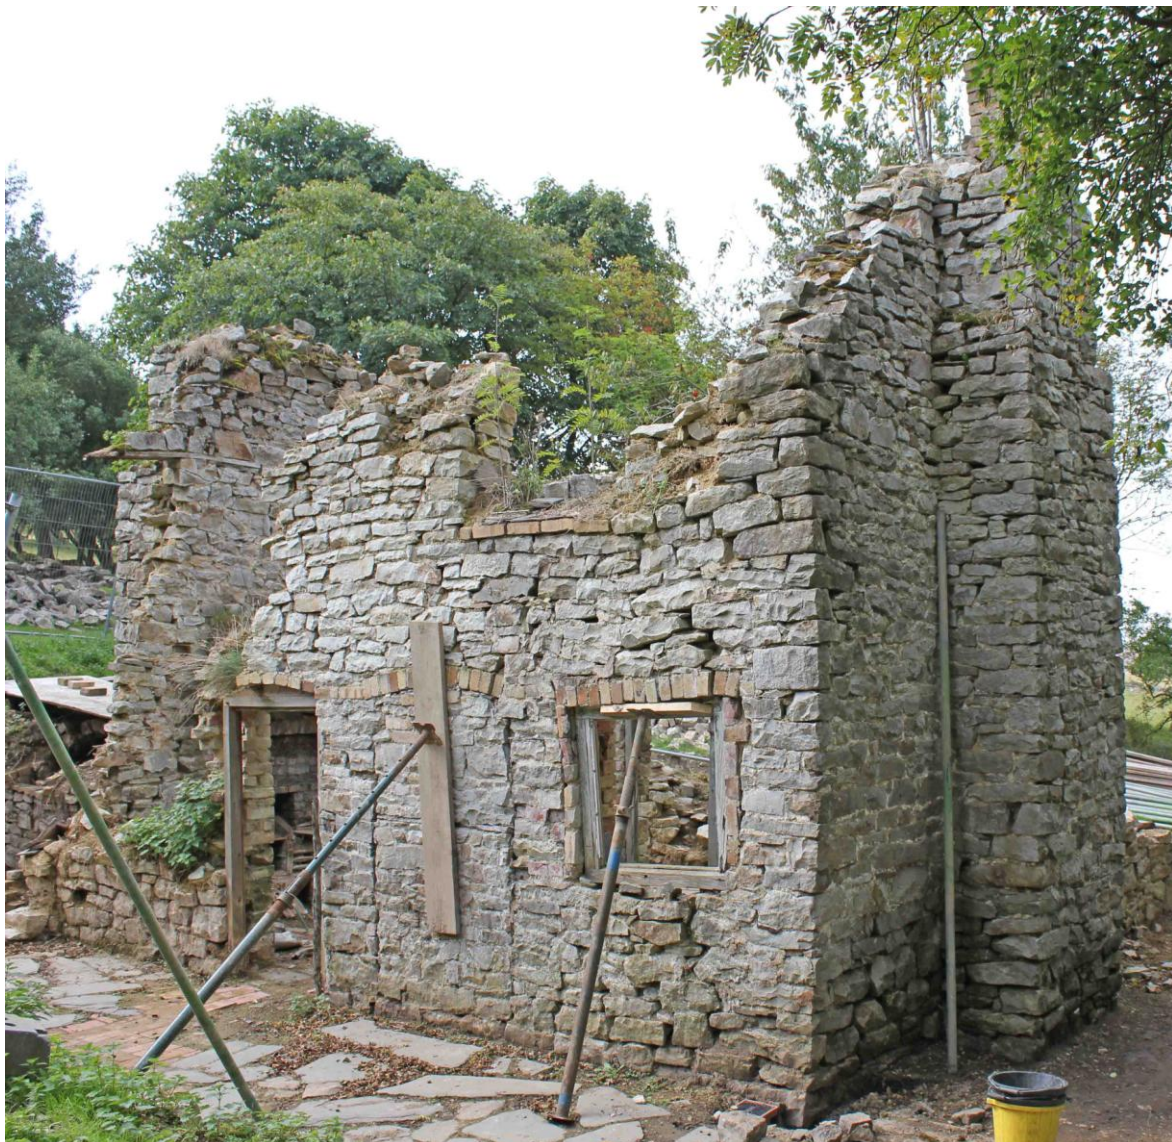
The walls are strongly built from the local stone, which lends itself to the production of very even building blocks. The walls of houses are about half a metre thick. There was very little mortar or cement in evidence when restoration began, though some has been used in the rebuilding of houses. They were originally built with just clay or soil between the stones to provide protection against the wind and cold. Great care must have been taken in their construction for them to have survived as long as they have done.

Miners would have plenty of experience in using the local stone, as they made arches to support the mouths of adits and shafts. They would have been familiar with making timber supports underground, so constructing the wooden floor for the upper storeys of a house would have posed no problems. Unusually, this house appears to have been designed with two front doors. It was planned as two semi detached cottages, and then completed as one.

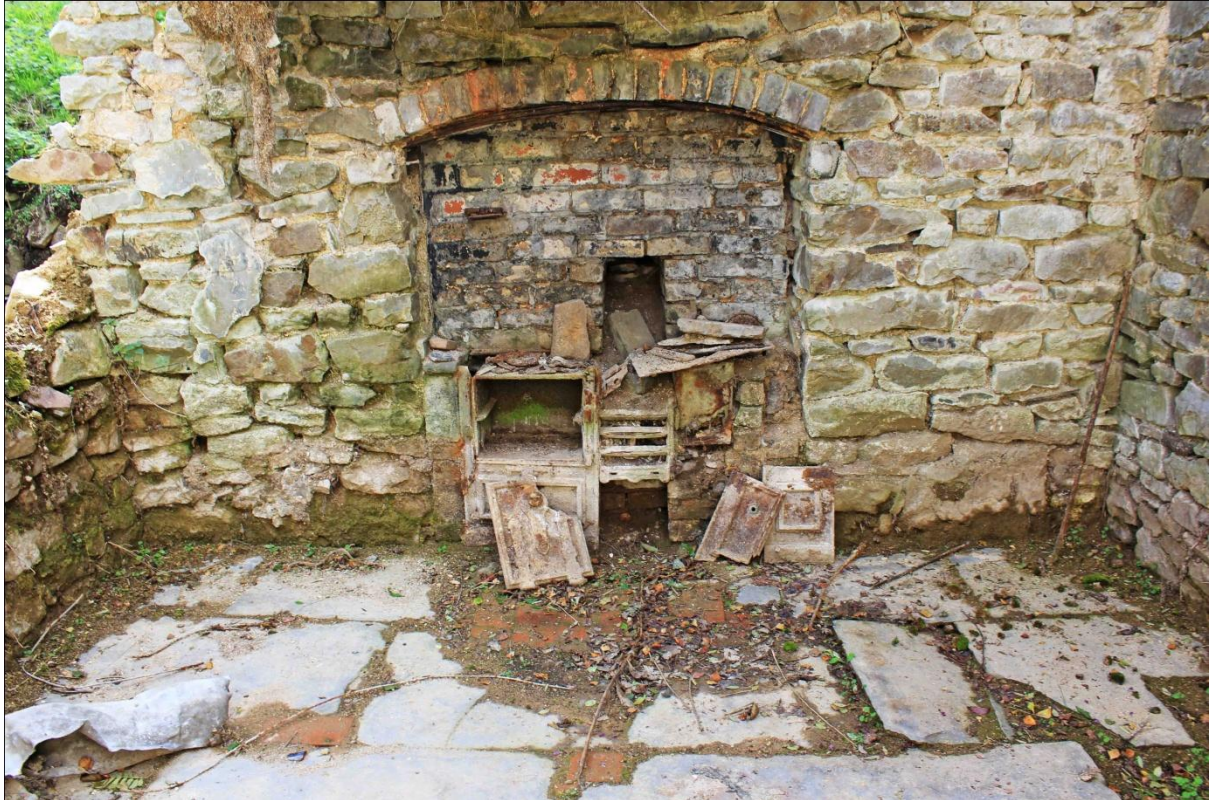
Inside Davies's Cottage

The unroofed house is known as Davies's Cottage as the last resident was Edwin 'Neddy' Davies. It has the remains of a substantial kitchen range, with an oven on the left side of the fireplace, and a container for hot water on the right. The floor still has the remains of its beautiful stone covering. There are chimneys at both ends of the house.

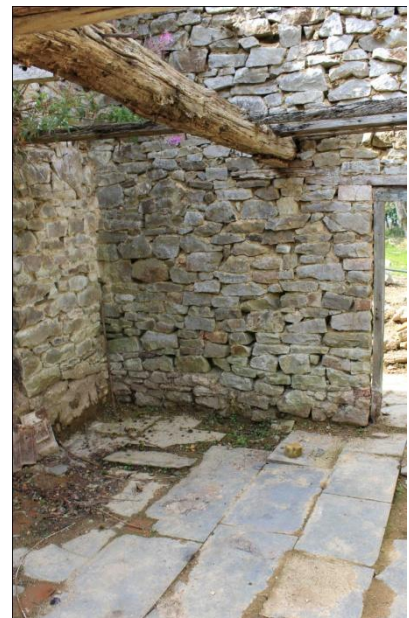
Many of the timbers used, like the joist which supported the upper floor of the house, were built into the house 'in the round' rather than being sawn to give square edges. This might indicate that those who built the cottages probably cut down the trees they needed rather than buying ready prepared timber. The steep slopes on the edge of the Stiperstones remain well wooded today. Most of the land has fairly young trees, so the older ones were used for building and for fuel.

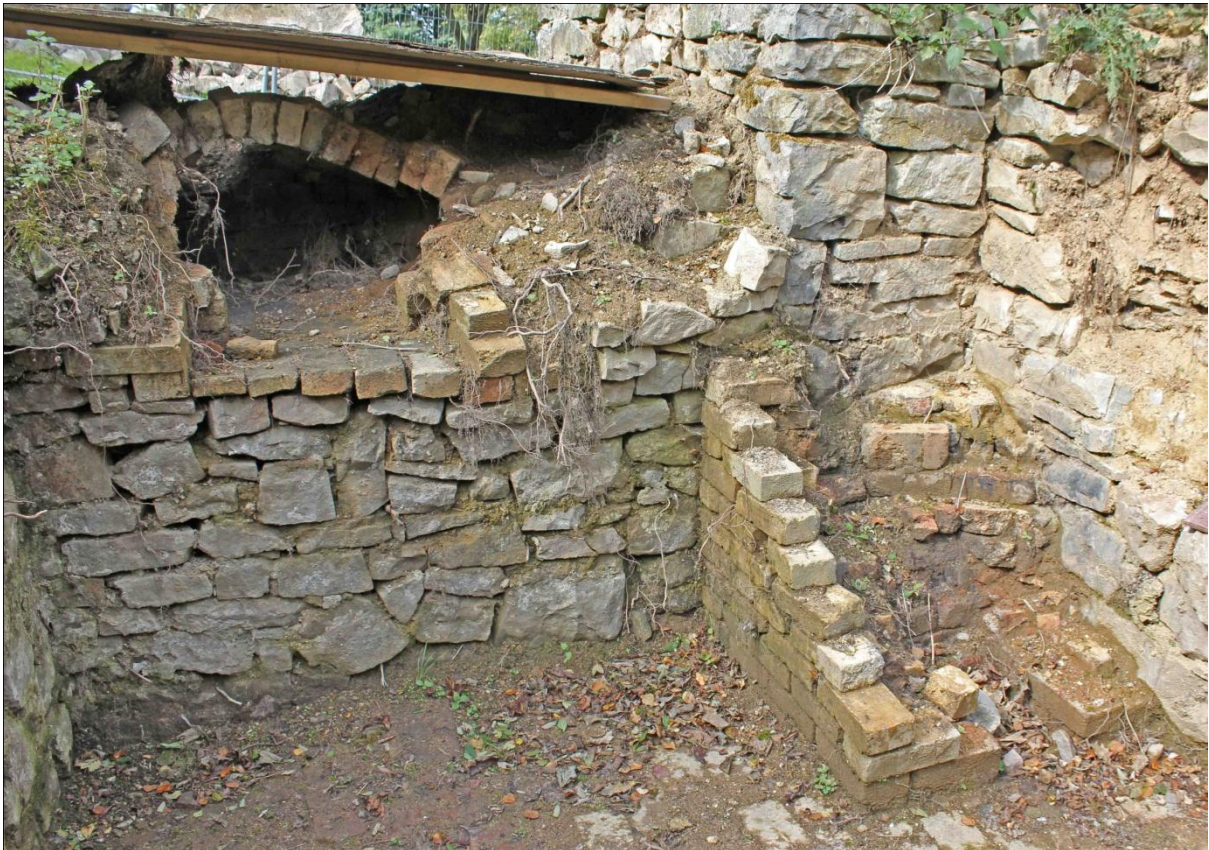
Outhouse

The inside of the outhouse reveals the complex construction of the chimney behind the kitchen range in the house. In the left side of the picture the brick arch marks the remains of a bread oven. To the right there would have been a copper over a fire for boiling water on wash day. Clearly the owners of these houses went to great lengths to make them comfortable. It is a good illustration of the resourcefulness of the people who lived here.

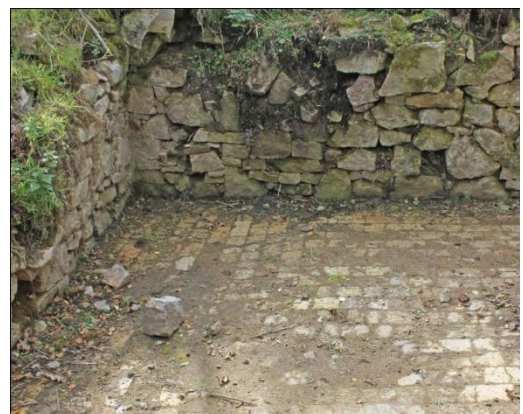
The yard in front of the house and outhouse is paved with bricks and flagstones so that mud isn't carried into the house on the boots of people living here.

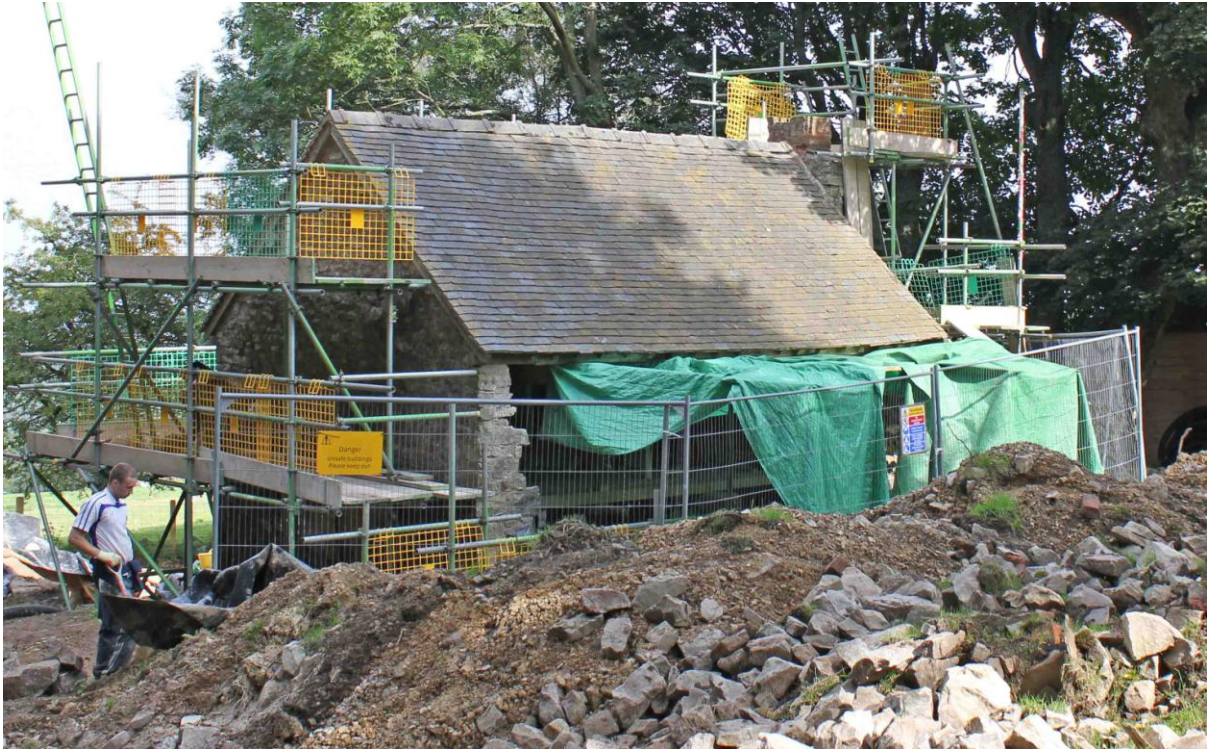
The best preserved house which had retained its roof is known as Cook's Cottage after the last residents Fanny and Robert Cook. It is a substantial two storey construction. Some plaster remains on the walls, with signs of blue paint. Plastering the walls would have helped the draught proofing of the houses as well as adding to the appearance of the homes. The upstairs was divided by a partition into two rooms; one for the parents and the other for the children.

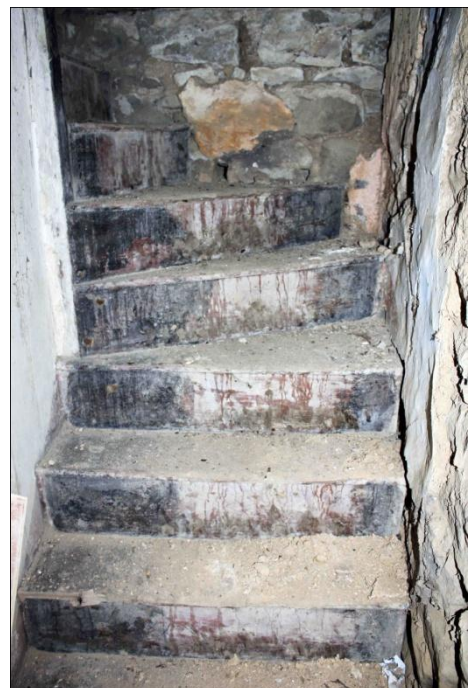
There is a narrow, well constructed staircase in the corner of the house. It would probably have had doors at the top and bottom in order to reduce draughts.

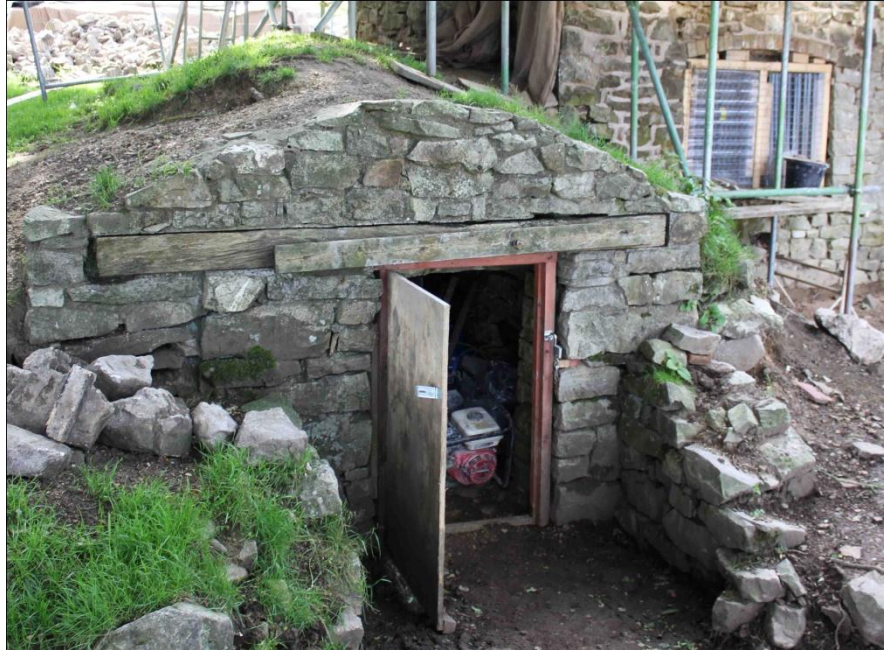
Vegetable Store

Outside the roofed house is a vegetable store, a low building with an arched roof well insulated with soil and turf. This would have been ideal for giving dark, frost free protection for potatoes and other vegetables during the winter. Frost would make the potatoes turn black, whilst light would make them turn green and start sprouting.

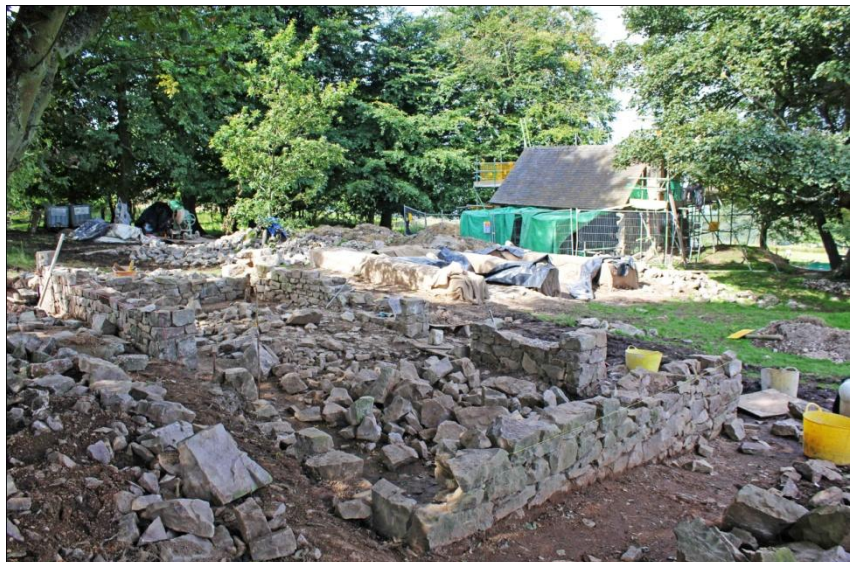
Cattle Sheds

Round the back are the remains of a Byre for cows and also, closer to the house, Pig Sties. The buildings for animals and for storing hay would not have been so strongly built as the houses, and little remains of these.

The Byre is being rebuilt as a shelter for school groups.

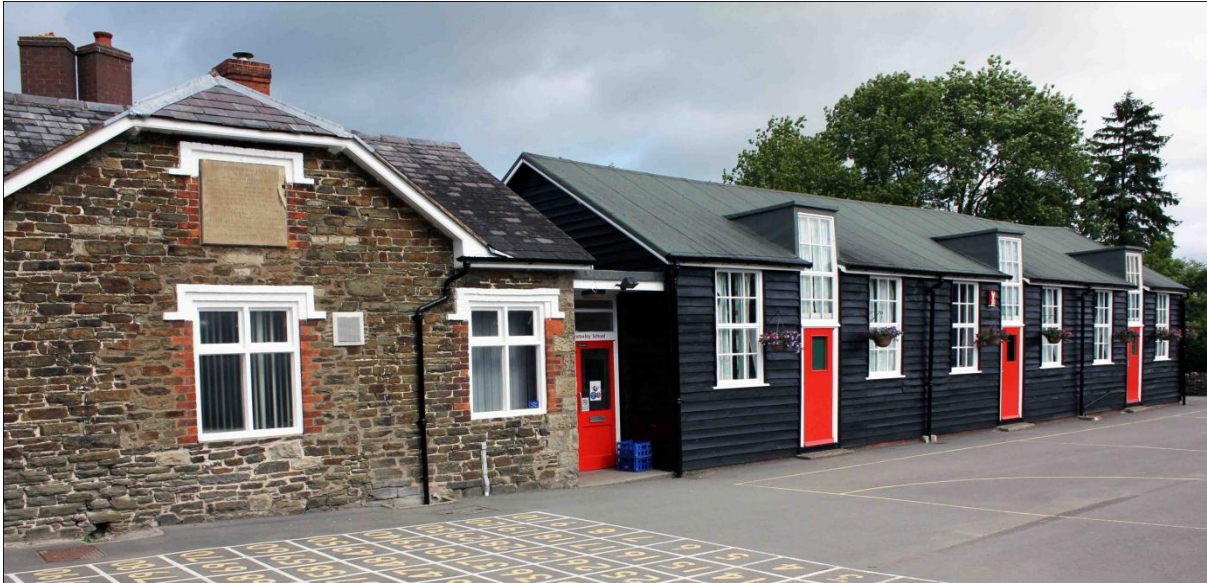
The local stone has provided an abundant supply of cheap, easily worked building material. The oldest part of the primary school in Minsterley has survived in good order since 1845. As in the houses at Blakemoorgate, brick is only used around windows and doorways. The school provides ample evidence of the quality of construction possible, especially where, as in this case, lime mortar was available.
