# Spoil Tips and Mine Approach

# 1 Landscape seen from the Spoil Heaps

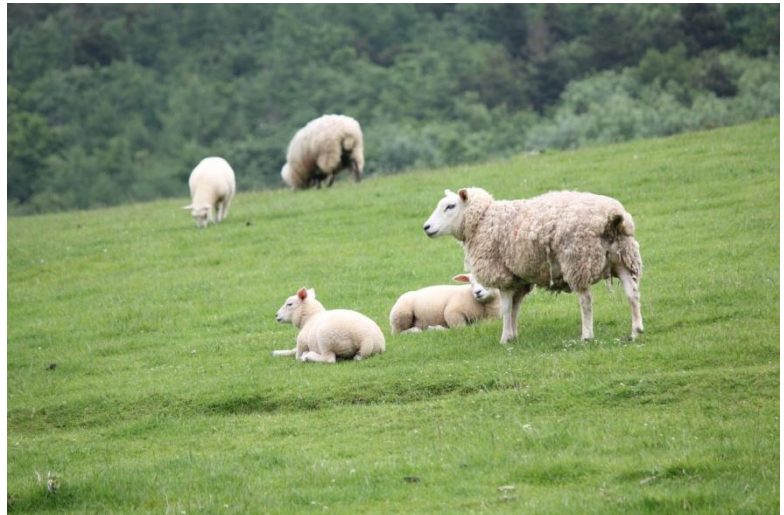
Until it was reclaimed by Shropshire County Council, this was part of the 'White Tip' of discarded rock from the mine.

Sheep grazing on the former White Tip

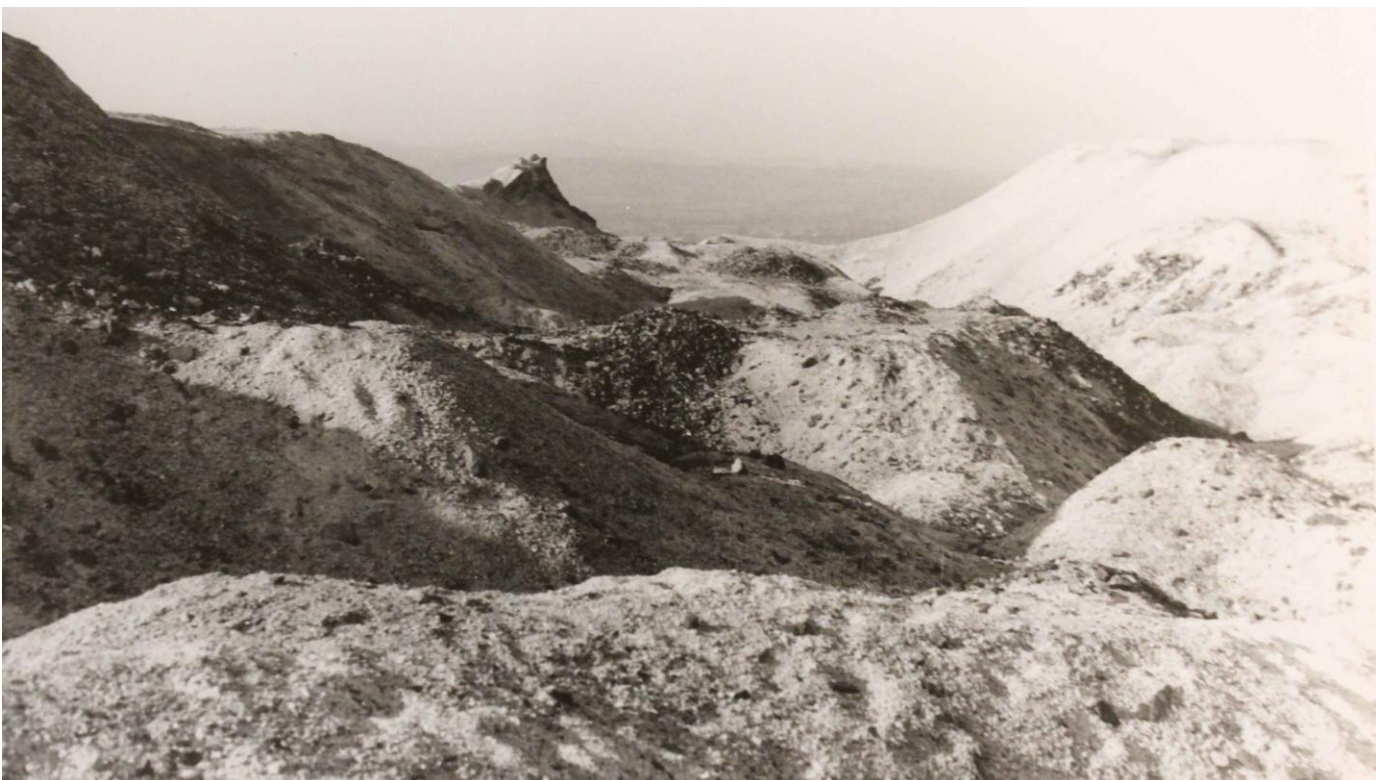
The White Tip before it was reclaimed . Photograph from Shropshire County Archive PH/S/20/26

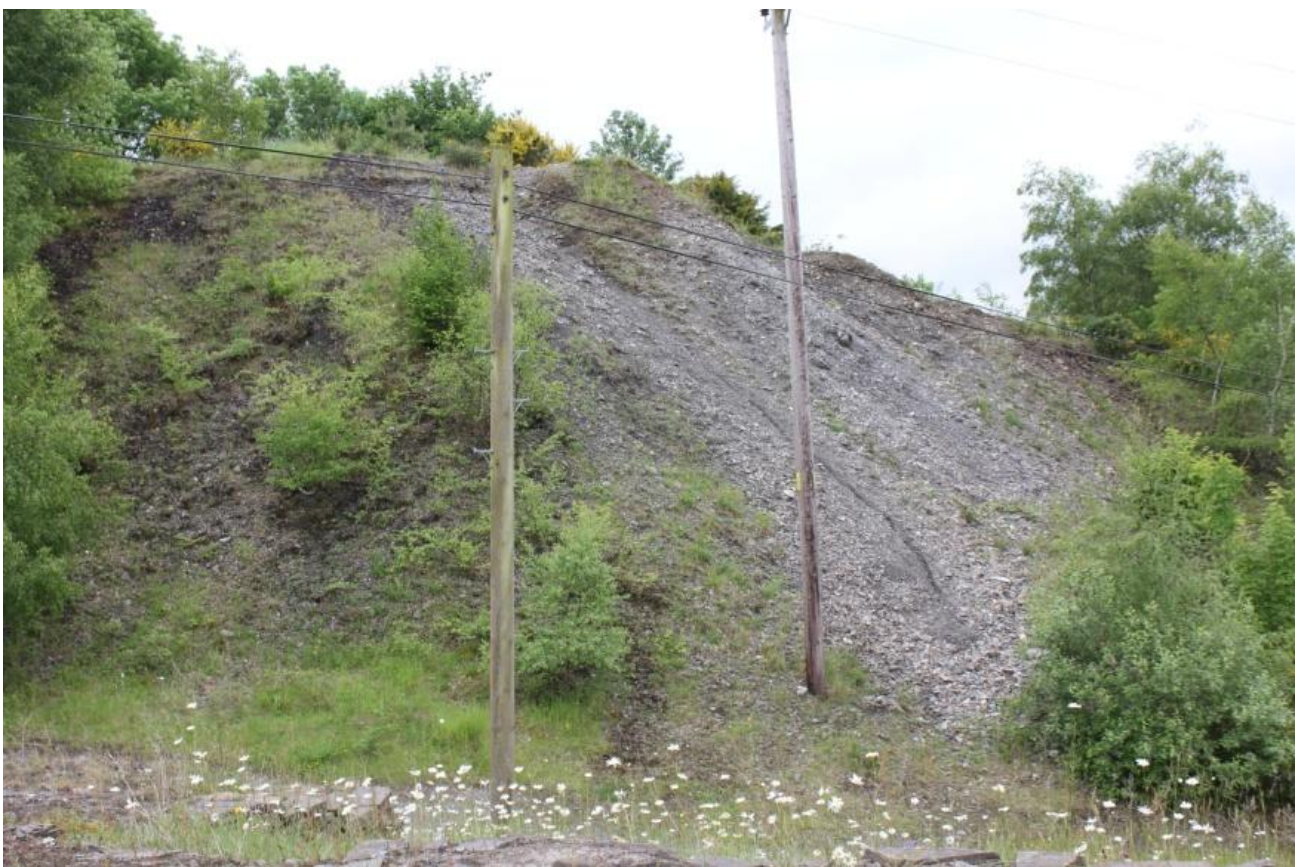
On the south side of the road the steep slope is clearly made of waste from the mine. It gives an impression of the way the landscape was disfigured by heaps of unstable spoil material on which nothing useful could be grown.

Tip on the north side of the road

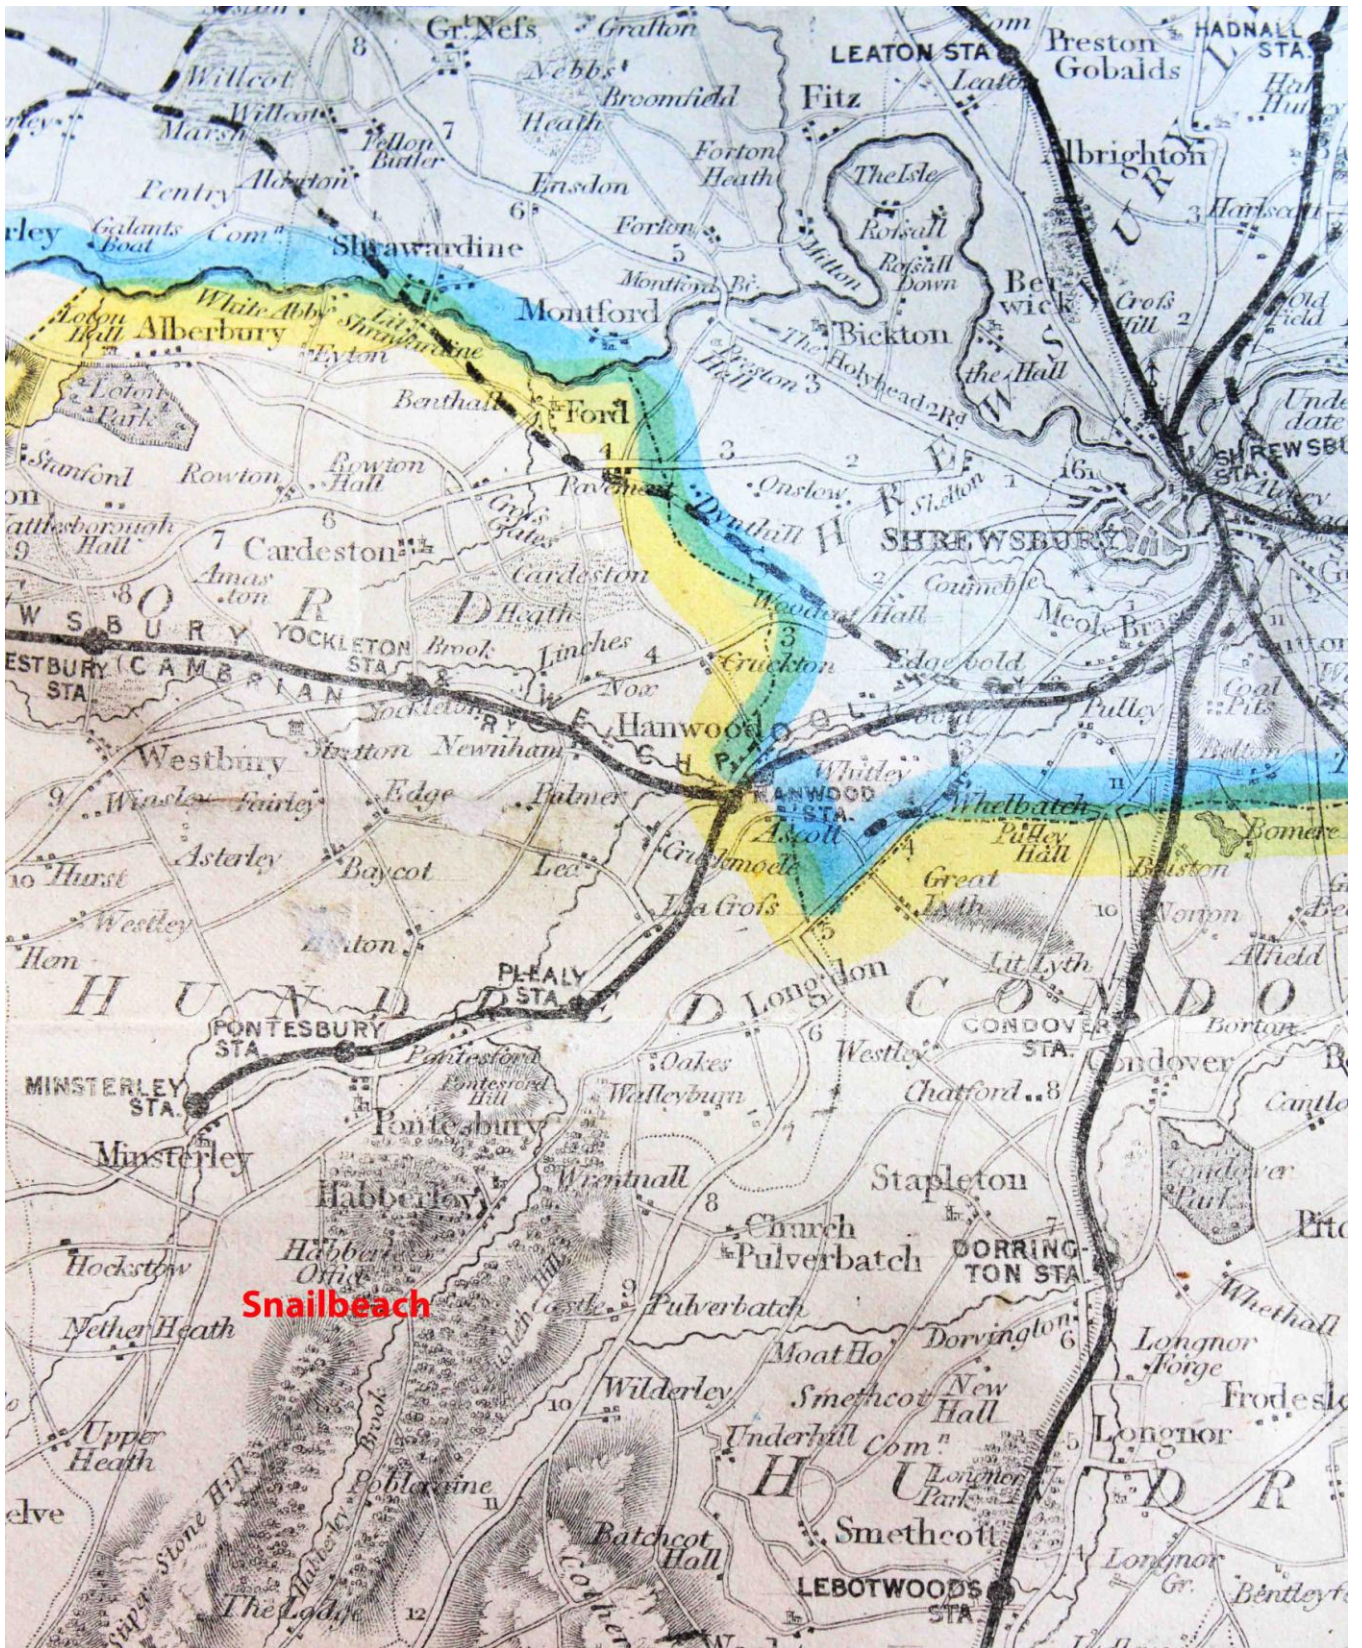
# 1870 Map

The map is an enlargement of part of a county map of Shropshire dated 1870. The railways are shown as continuous lines, and the railway to Minsterley from Hanwood, completed in 1861, is marked. Planned railway lines are shown as dashed lines, but not all of these would necessarily be constructed. All of the railway information is up to date because any railway required an Act of Parliament, and information about the line was published. Other information could be out of date.

The position of Snailbeach is indicated in red on the map. Note that the map makers have completely ignored all developments at Snailbeach. It is not yet regarded as a place to identify. Looking at the photograph of Snailbeach on Sheet 4, the only structure which is likely to have been present when the map was made was George's Shaft, marked on the ground today by the reconstructed pit head gear. Most of the significant mine buildings, like the chimney with the date 1881, are likely to have been built after the map was made. Miners would have lived on their smallholdings, and the steep valley sides of Snailbeach have never been suitable for growing crops.

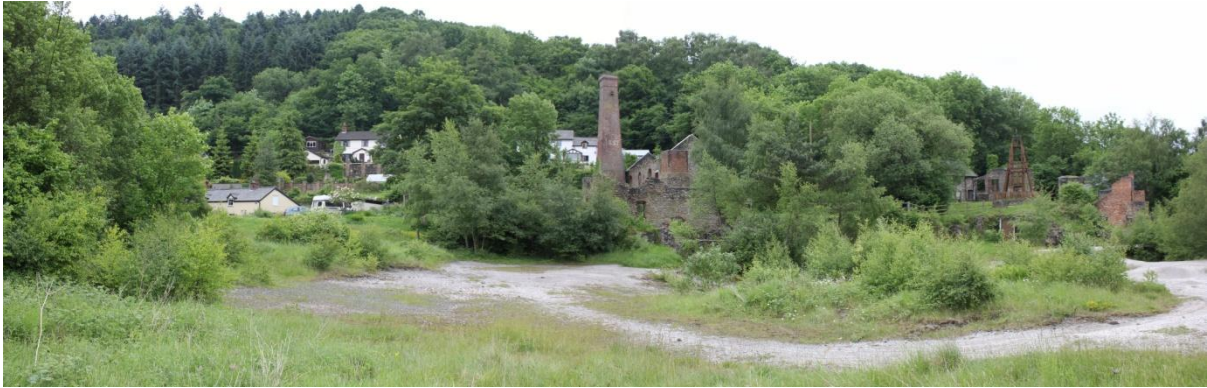
The photograph shows the view of the former mine on the South side of the Snailbeach Valley. The name SNAILBEACH originally applied to the valley, before there was a mine or a village. The word BEACH originally means a watercourse. Less than 2 kilometres south of Snailbeach there is a similar steep sided valley called Perkins Beach. The original natural vegetation of the steep sided valley is seen in the trees on the hillside.

The level area in the foreground of the photograph has been created by dumping mine waste, and it was levelled to accommodate mine buildings and equipment for 'dressing' the ore; that is, separating Galena, lead ore, from waste rock and other minerals.

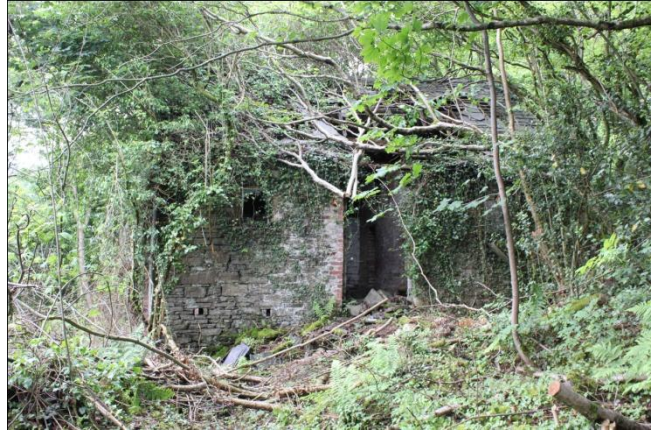
## Candle House

One is the former Candle House, just below the road on the north side. It is not in the care of either the County Council or English Heritage, and is extremely dilapidated. This is where tallow, animal fat, was rendered down to make candles for use in the mine. The fat was likely to be old and rancid, and boiling it would have created a terrible smell. This explains why the Candle House was sited away from other mine activities.

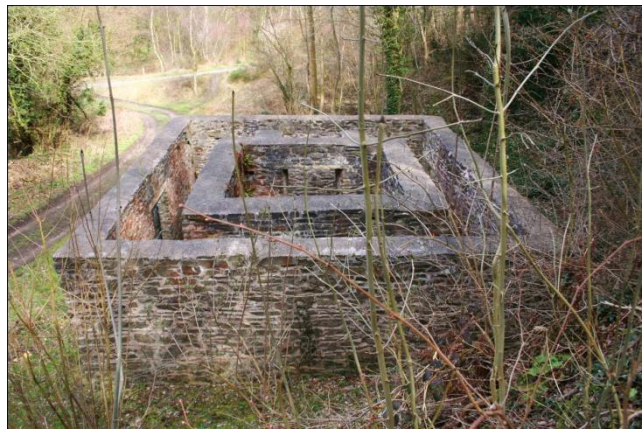
## The Magazine

The Magazine, a building with strong double walls, was built here for safety. This was a store for gunpowder and other explosives used in the mine.

The roof would have been very lightly built so that if an explosion occurred inside, the roof would blow off but the walls would remain intact. The walls have remained in good repair because they were very strongly built, and the Magazine continued in use until mining of Barytes ceased in the 1950s.

The Magazine is labelled on large scale Ordnance Survey maps from 1880 and 1900. It is shown as having a double wall, with only the central part of the Magazine roofed.

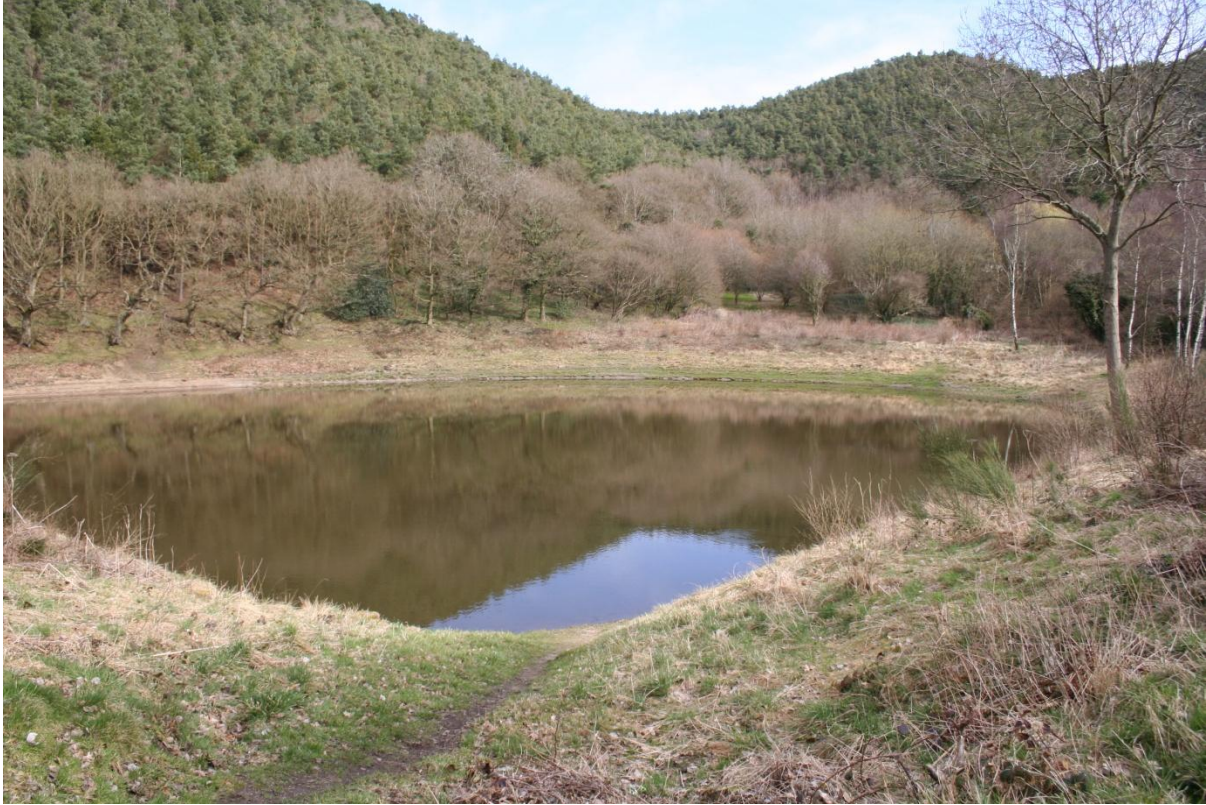
The reservoir fills the steep sided valley. It is positioned above the mine so that water will be supplied under pressure for use in mineral dressing. From the lower side of the dam it is possible to appreciate how steep the valley sides are and how deep the reservoir must be. Towards the far side of the dam is the former Valve House from where the flow of water could be managed.

The stream entering the reservoir (towards the right hand corner in the above photograph) has started to fill the reservoir with sediment. This has provided a habitat for marsh plants such as the Irises shown on the right.

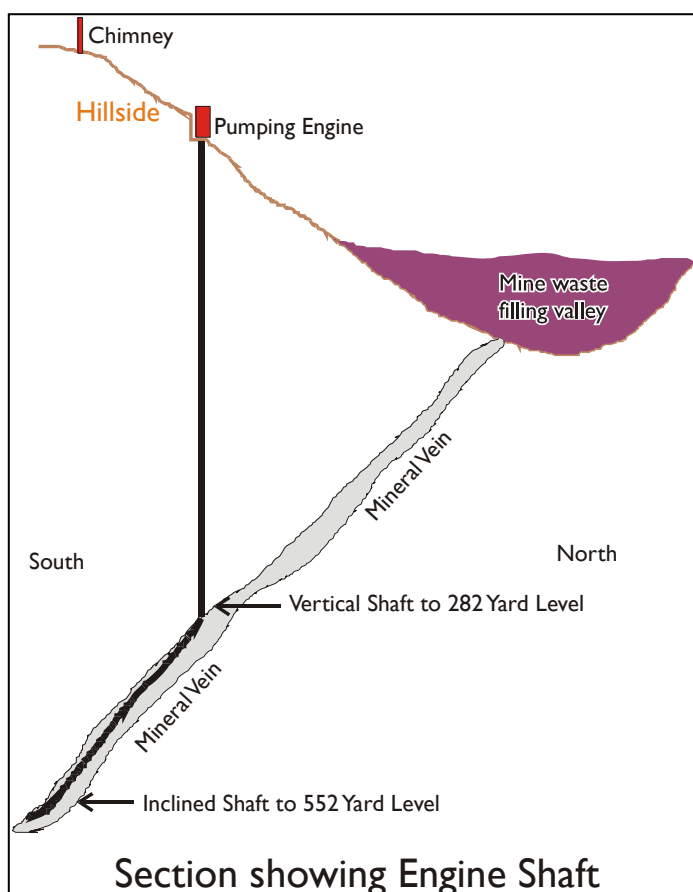
The various LEVELS are horizontal tunnels which follow the line of the Snailbeach Vein. The depth of each tunnel, measured in Yards, is calculated from the top of George's Shaft.

The Levels twist and turn, following the irregular path on which miners found the richest part of the vein, and they run roughly from East to West. The shallowest Levels are towards the north of the mined area, and the deepest Levels are further South. This shows that the mineral vein is inclined. It dips, or 'hades' to use the geological term, at a steep angle to the south.

This means that as George's Shaft was made deeper it missed the mineral vein completely. But because the Mine Manager was confident that more lead could be mined by going deeper, a new shaft was dug to the South of George's Shaft. As the map indicates, Engine Shaft meets the lead vein at the 282 Yard Level. Then, in order to follow the vein to a greater depth, it was extended as a steeply sloping shaft. This would have saved the expense of making another shaft even higher on the hill.

As the plan shows, the mineral vein comes to the surface (outcrops) somewhere north of the mine workings,

but the actual location is covered by mine waste which now fills the valley floor.

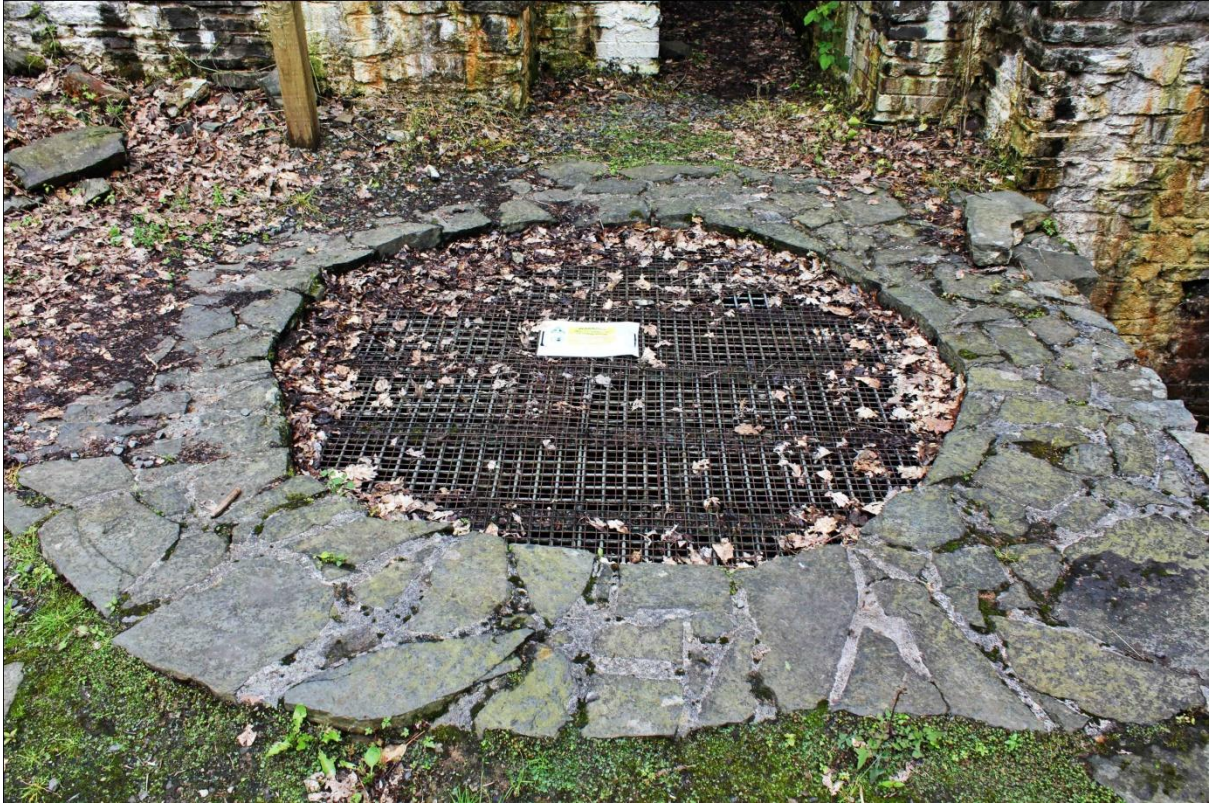
The steel mesh covers a shaft which descends 450 metres. The shaft is vertical for about 300 metres and then it descends at an angle, following the vein of Lead Ore. The lower part of the shaft cannot be explored because water needed to be pumped out of the mine constantly, and the pumping engine was turned off 100 years ago.

The opening at the top of the shaft looks quite small. The top has been reconstructed and is narrower than it originally was. This shaft was used to raise Lead Ore as far as Day Level, and it also housed the long rod connected to the pumping engine. This is because it wasn't used by men to reach the mine. Nor was it used to bring Lead Ore out.

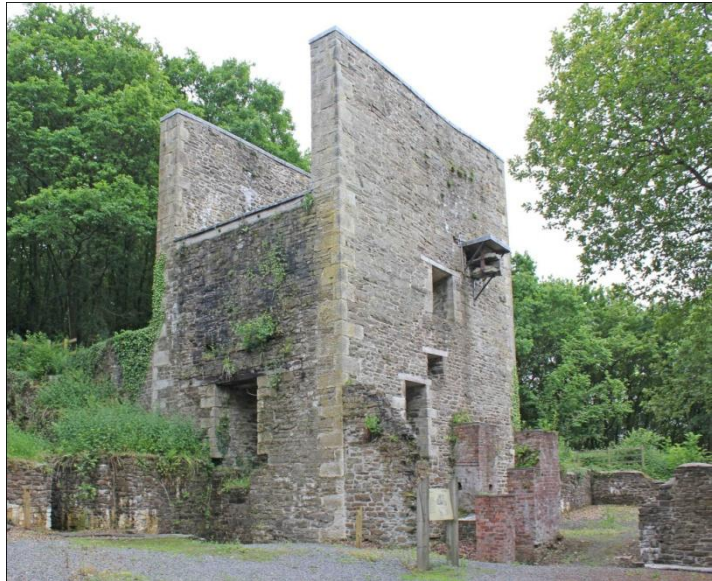
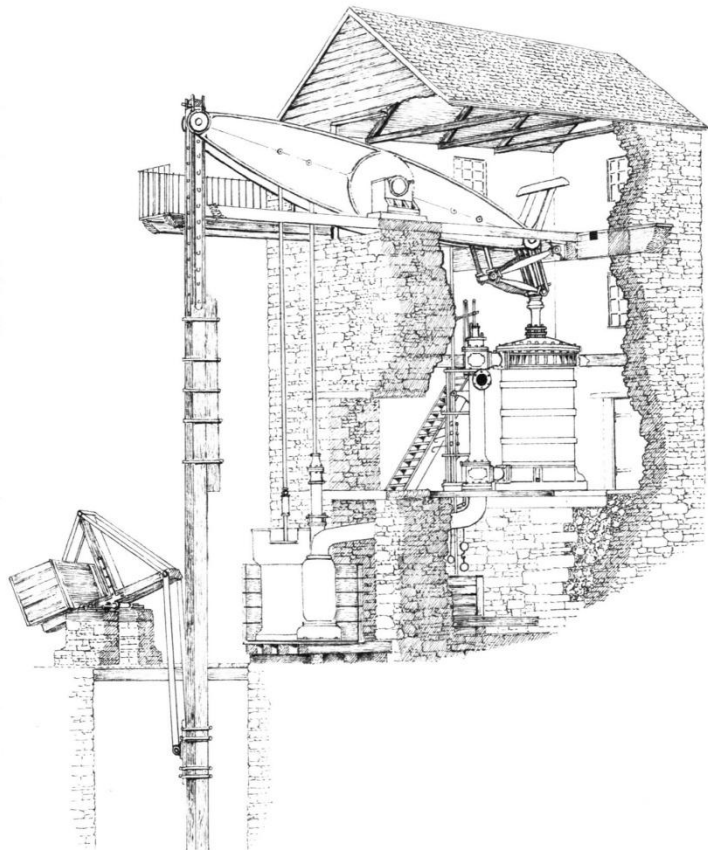
Pumping Engine by M. Newton 1

The diagram below shows the machinery contained inside this building. It was a huge steam driven pumping engine completed in 1858.

The low wall facing the photograph was the strongest part of the building, because it supported the weight of a massive beam which stuck out of the building, and was connected to rods which went down the mine shaft. To balance the weight of the long rod, weights in a balance box, shown on the left of the diagram would have given some support. Today there is only a depression in the ground to show where this would have been.

The cylinder of the steam engine which powered the movement of the beam had a diameter of about one and a half metres.

Presumably this engine ran for 50 years until pumping stopped in 1910. It must have proved remarkably reliable, and it would have needed careful maintenance. Notice the platform from the building going to the end of the beam to allow the engine man to grease the joint at the end.

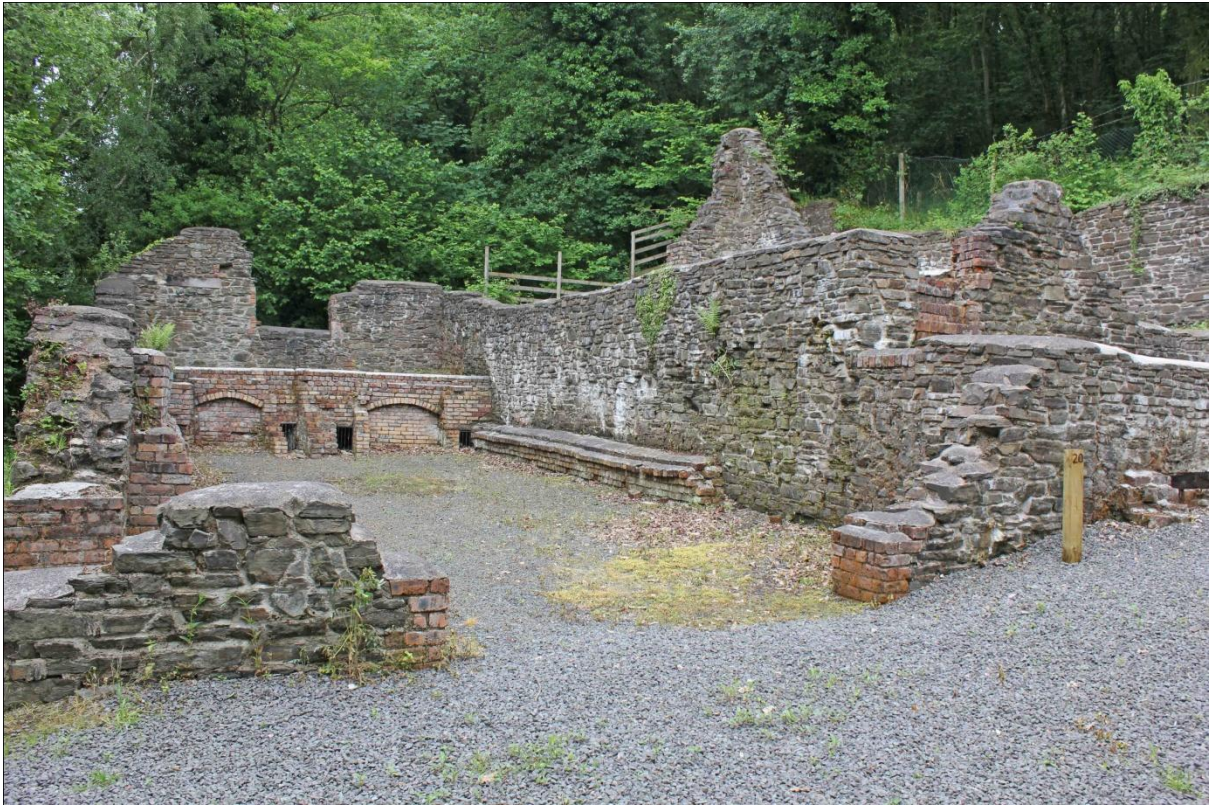
There is no indication of the machinery which filled this building but its size gives an impression of the power of the boilers needed to raise Lead Ore and waste rock up the mine shaft. There appear to have been two large boilers side by side. There was no need for a large head gear like the one over George's Shaft because the rock was not brought to the surface.

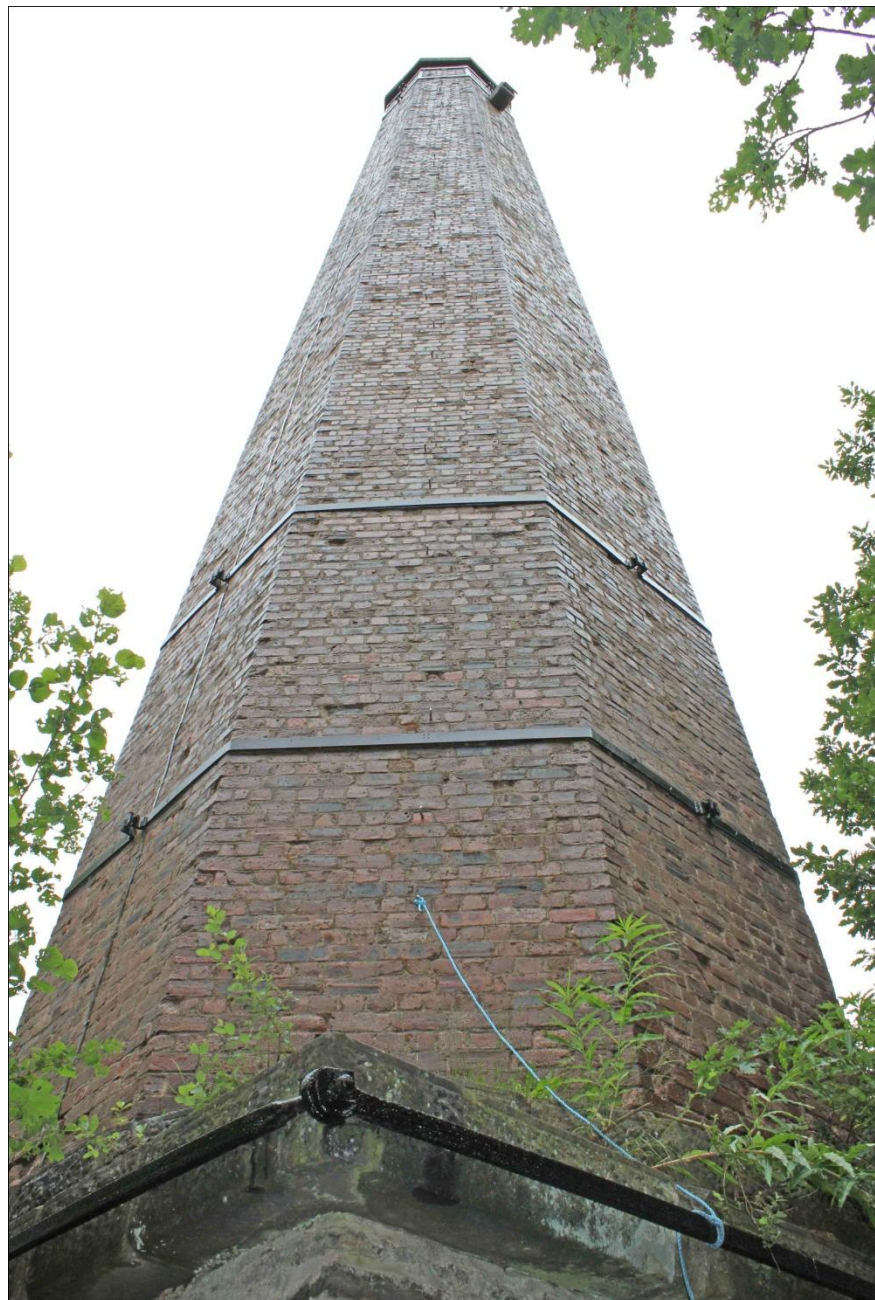
The chimney was built to serve the Smelter constructed a mile north of here at Snailbeach and connected to this chimney by a mile long flue.
