# Blakemoorgate

The remains of several miners' cottages at Blakemoorgate at the northern end of the Stiperstones are being renovated by English Nature. They already provide a clear indication of the way of life of Snailbeach Miners.

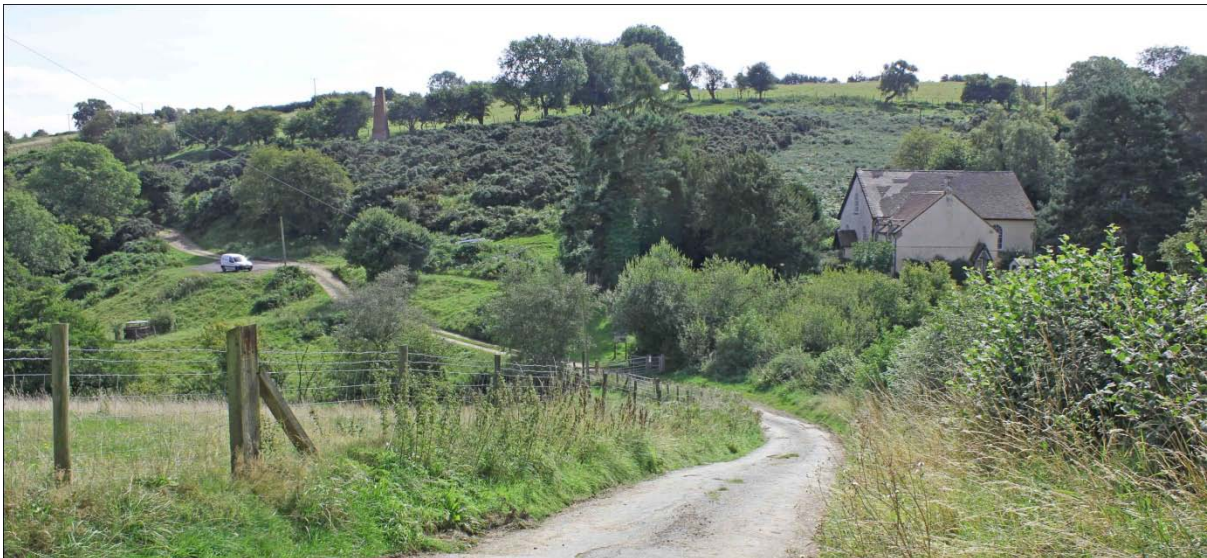
From there, follow the narrow road which is signposted to Lordshill. As the road emerges from woodland into fields the circular stone built caps on two shafts can be seen.

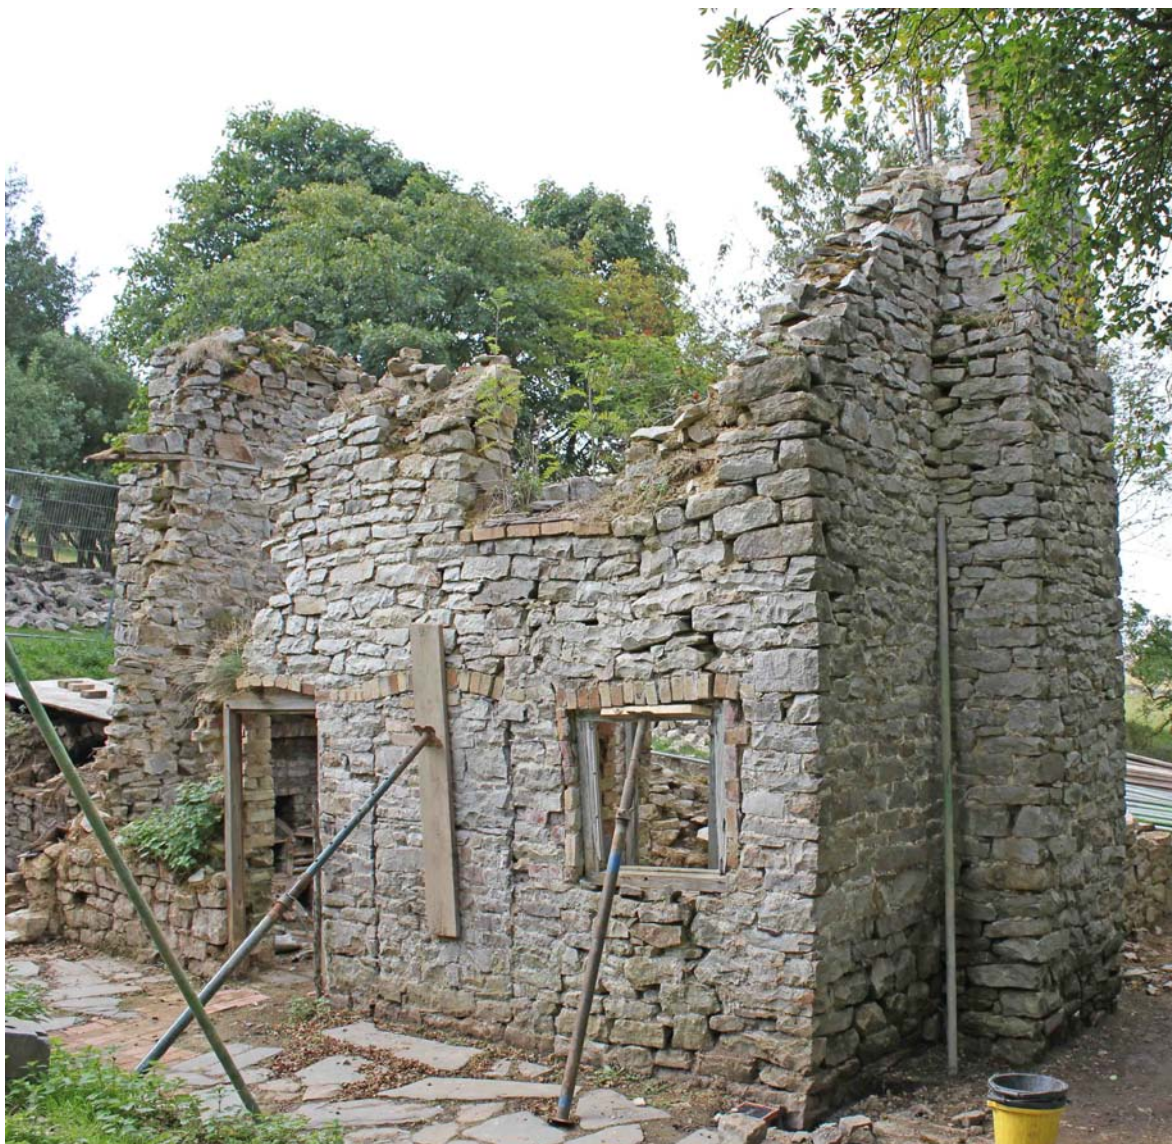
The walls are strongly built from the local stone, which lends itself to the production of very even flagstones. The walls of houses are about half a metre thick. There was very little mortar or cement in evidence when restoration began, though some has been used in the rebuilding of houses. They were originally built with just clay or soil between the stones to provide protection against the wind and cold. Great care must have been taken in their construction for them to have survived as long as they have done.

Miners would have plenty of experience in using the local stone, as arches were constructed to support the mouths of adits and shafts. They would have been familiar with making timber supports underground, so constructing the wooden floor for the upper storeys of a house would have posed no problems.

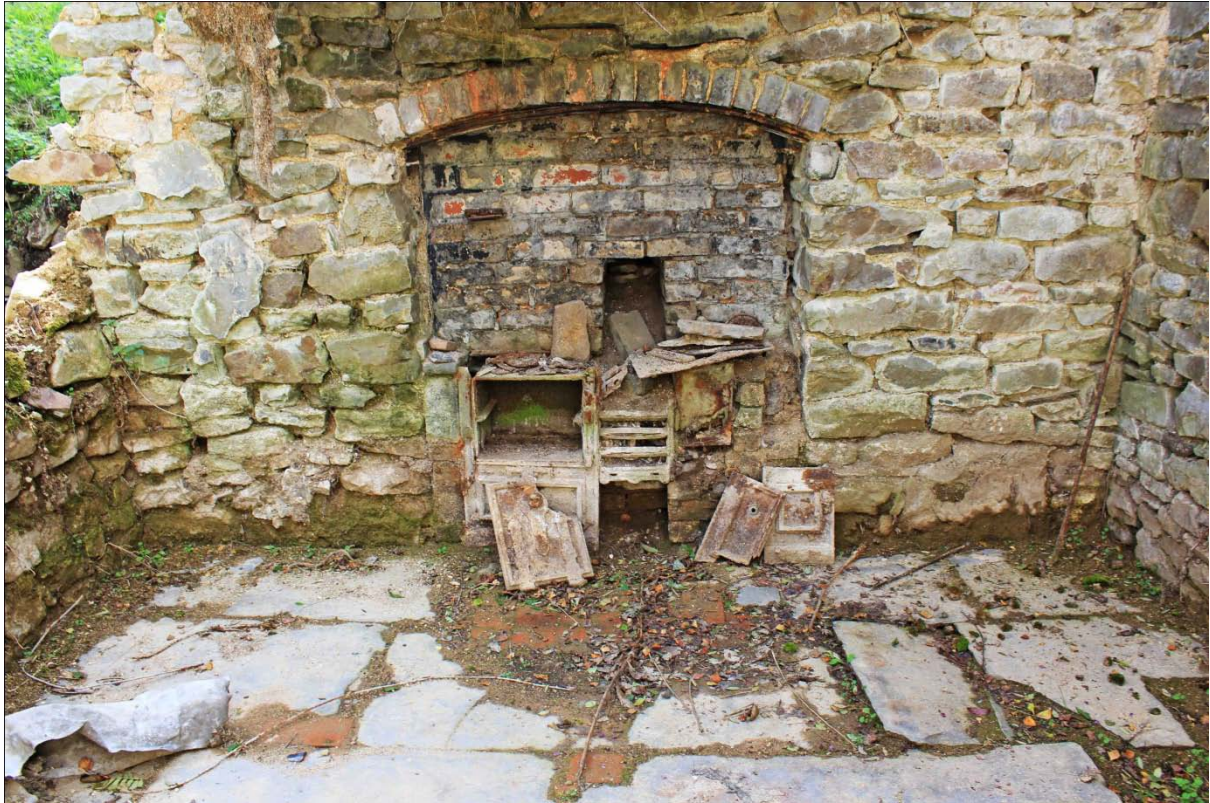
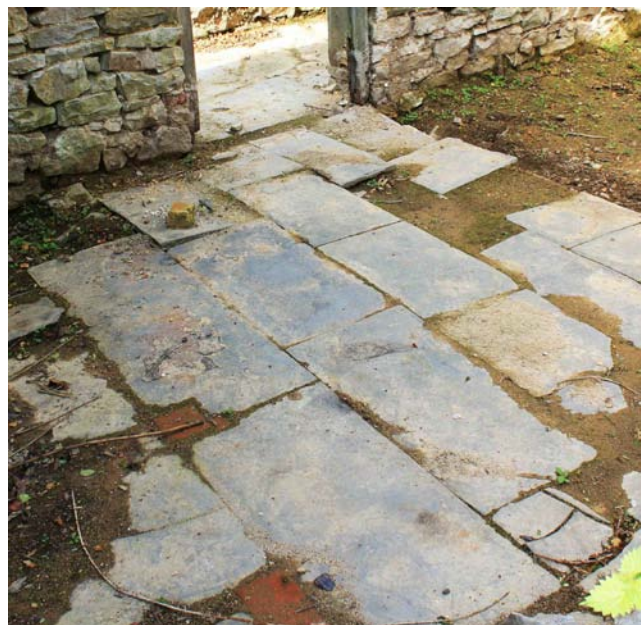
The unroofed house has the remains of a substantial kitchen range, with an oven on the left side of the fireplace, and a container for hot water on the right. The floor still has the remains of its beautiful flagstone covering. There are chimneys at both ends of the house.

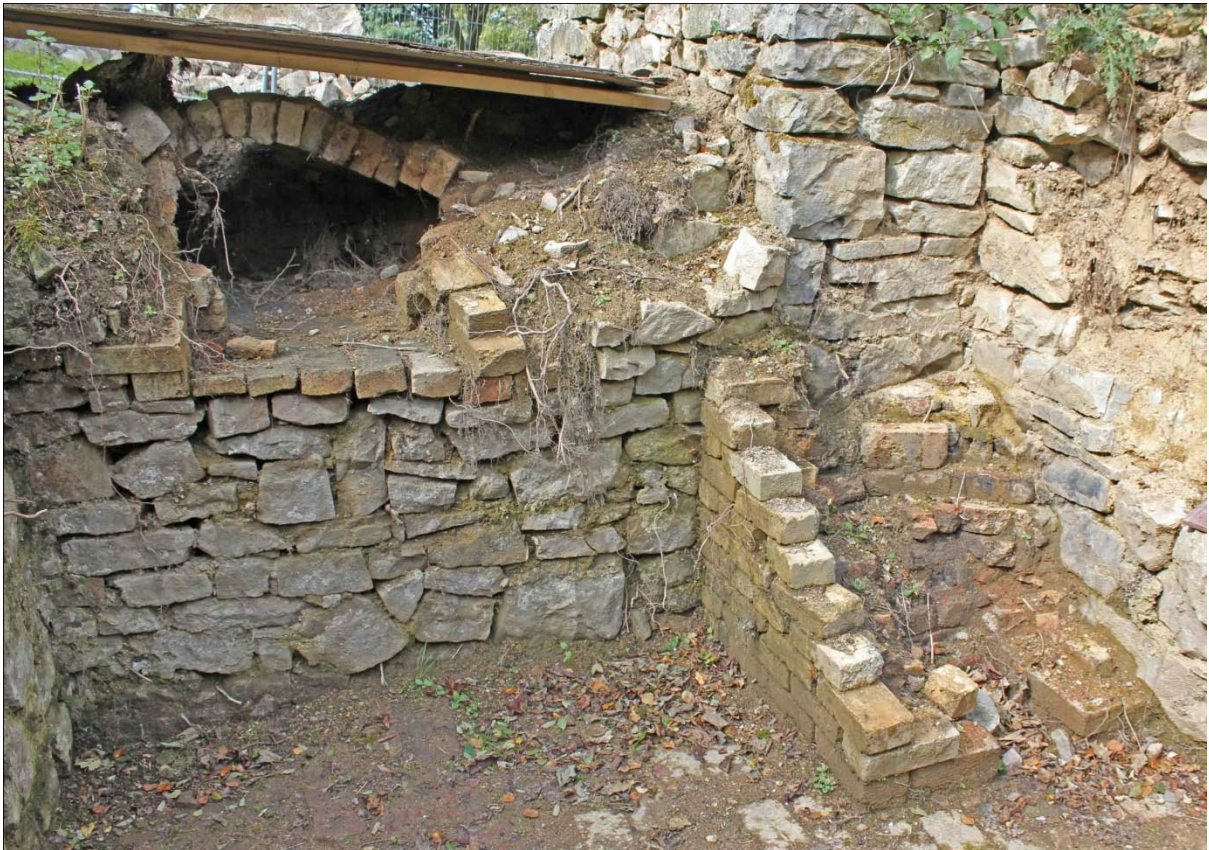
The inside of the outhouse reveals the complex construction of the chimney behind the kitchen range in the house. In the left side of the picture the brick arch reveals the remains of a bread oven. To the right there would have been a copper over a fire for boiling water on wash day. Clearly the owners of these houses went to great lengths to make them comfortable. It is a good illustration of the resourcefulness of the people who lived here.

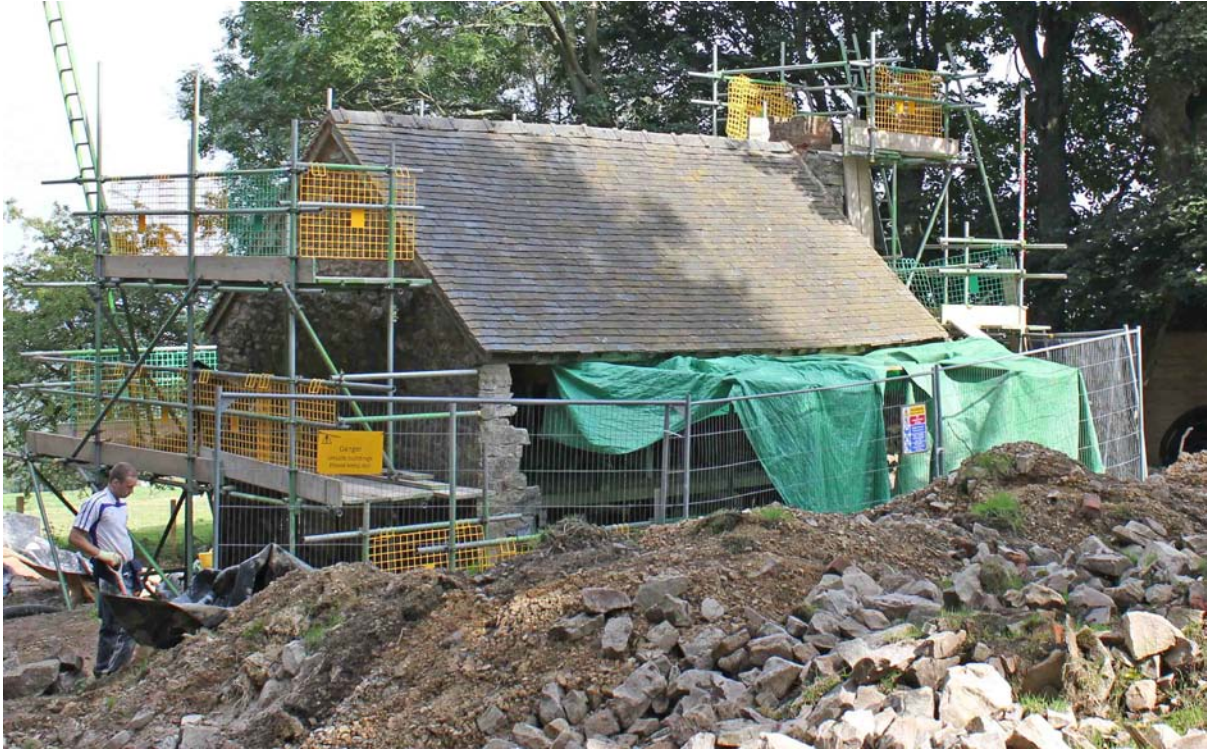
The house which has retained its roof shows a substantial two storey construction. Some plaster remains on the walls, with signs of blue paint. Plastering the walls would have helped the draught proofing of the houses as well as adding to the appearance of the homes.

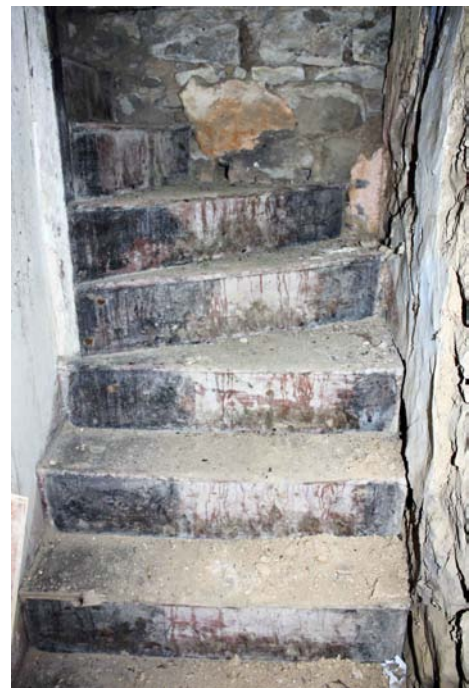
There is a narrow, well constructed staircase in the corner of the house. It would probably have had doors at the top and bottom in order to reduce draughts.

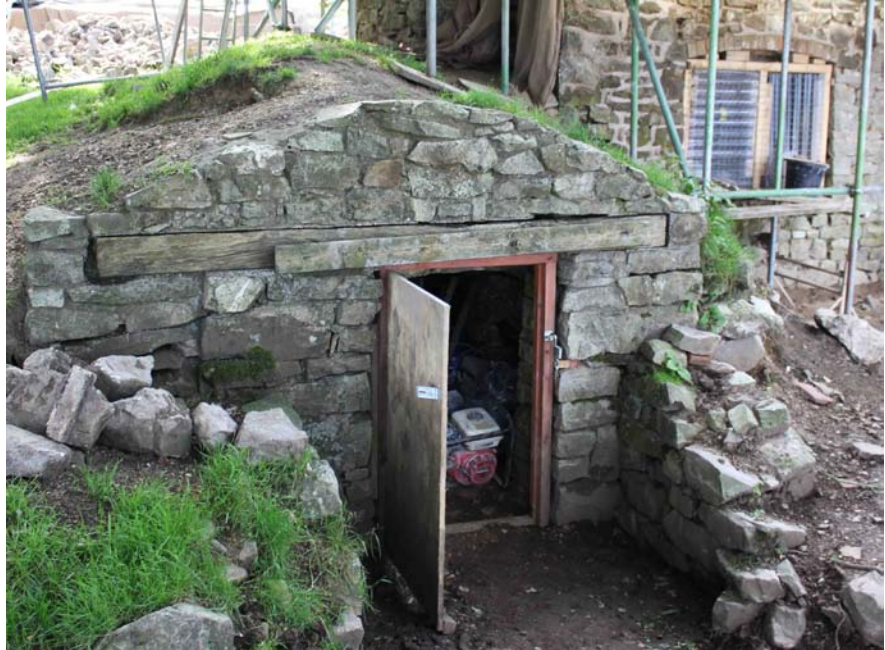
Outside the roofed house is a vegetable store, a low building with an arched roof well insulated with soil and turf. This would have been ideal for giving dark, frost free protection for potatoes and other vegetables during the winter. Frost would make the potatoes turn black, whilst light would make them turn green and start sprouting.

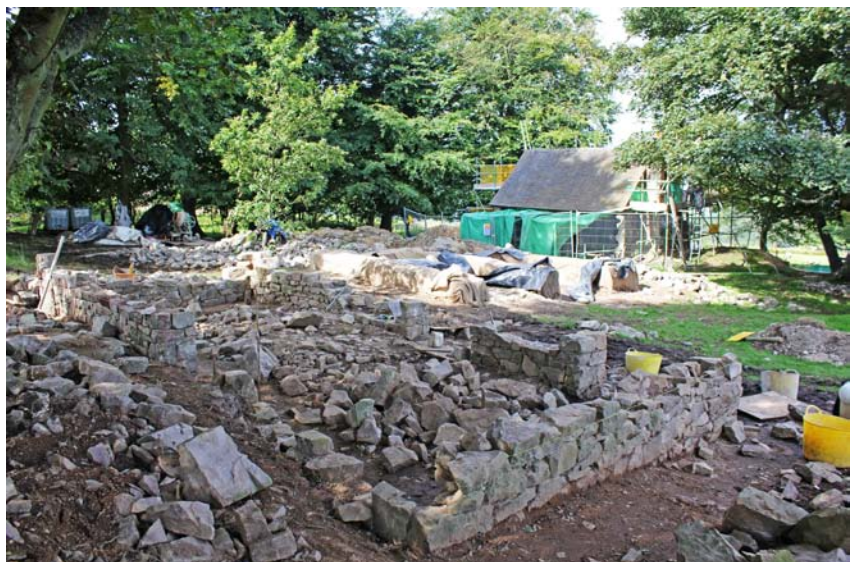
Round the back are the remains of another house and cattle sheds. The buildings for animals and for storing hay would not have been so strongly built as the houses, and little remains of these.

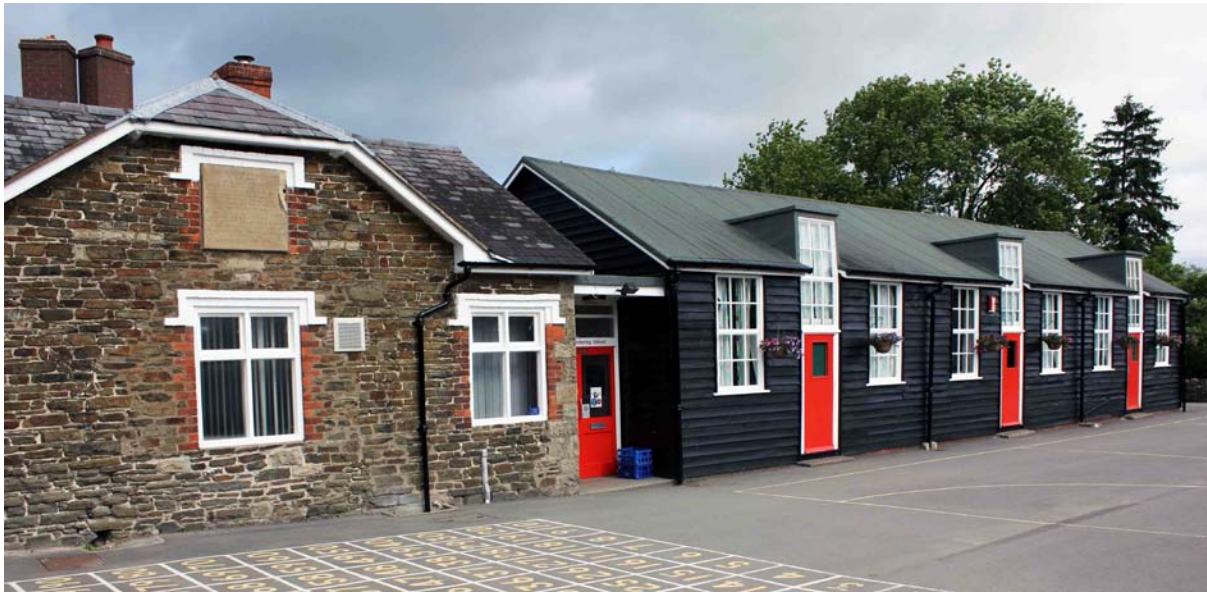
The local stone has provided an abundant supply of cheap, easily worked building material. The oldest part of the primary school in Minsterley has survived in good order since 1845. As in the houses at Blakemoorgate, brick is only used around windows and doorways. The school provides ample evidence of the quality of construction possible, especially where, as in this case, lime mortar was available.
